FY 2017 Status of Sodium Freezing and Remelting Tests

Nuclear Engineering Division

Q. Lv, E. Boron, Y. Momozaki, D. B. Chojnowski, J. J. Sienicki, and C. B. Reed
Nuclear Engineering Division, Argonne National Laboratory

September 15, 2017

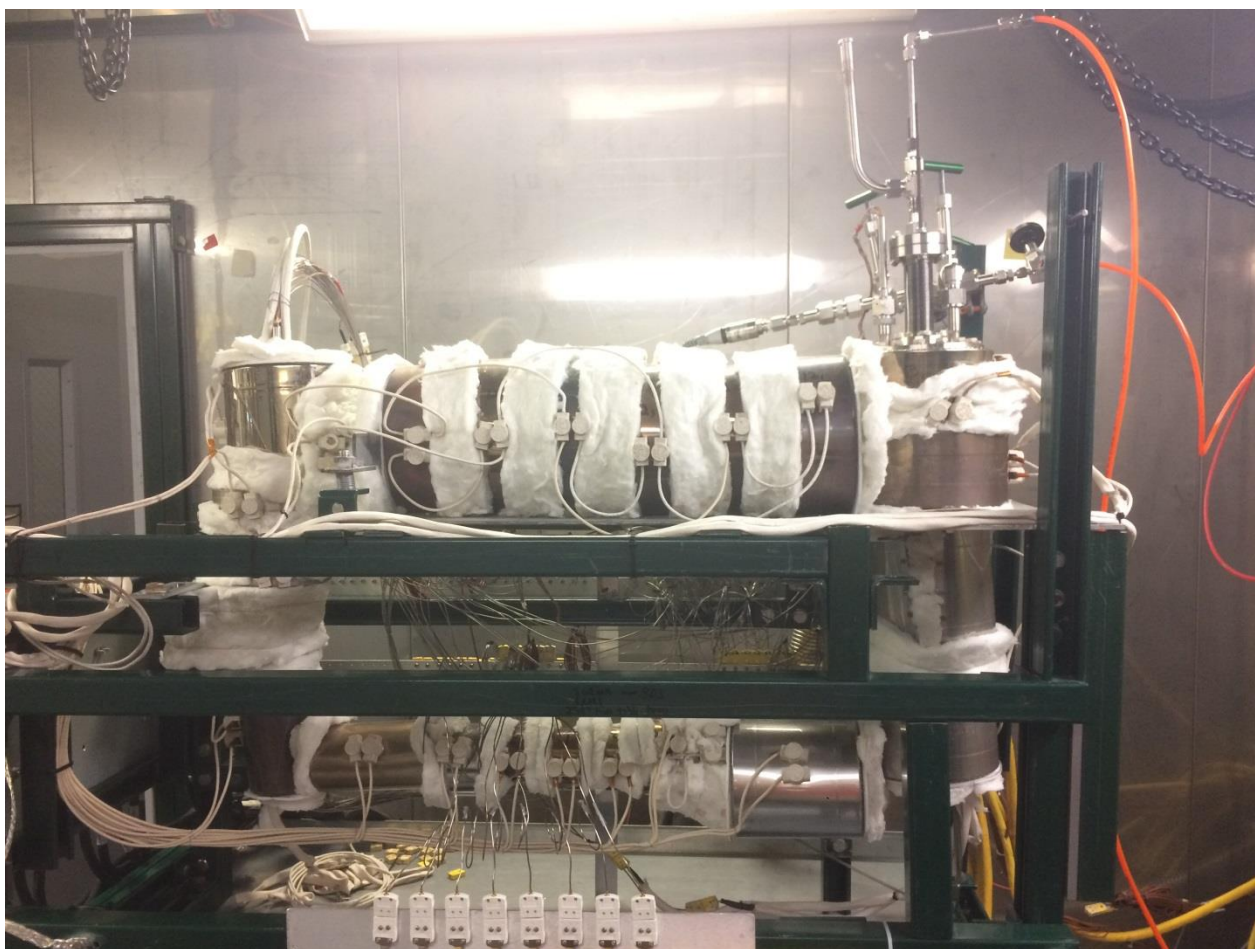
The upgraded Freezing and Remelting test facility, as shown in Figure 1 and Figure 2, is a simple closed loop system only partially filled with sodium. This test facility consists of four main components: the test section in the bottom, the DC EM pump located in the small vertical leg, the sodium reservoir located in the opposite leg, and the cold finger submerged into the sodium reservoir. The small tubing, including the pump duct, is ½ inch outer diameter (OD) tubing; the fill reservoir is made from a 4-inch Schedule 80 pipe. Swagelok VCR fittings are used on all non-welded connections, except the top flange for the sodium reservoir. The system must be vacuum tight for bake-out prior to the initial sodium loading, so the top flange is sealed with a Conflat knife-edge seal design. The sodium freezing and remelting test section is connected using quick change VCR fittings to elbows below the sodium fill reservoir and the electromagnetic sodium pump. The cold finger is submerged in the sodium reservoir, and sealed to the reservoir cap with a conflat flange.

Figure 1. Upgraded Sodium Freezing and Remelting test facility

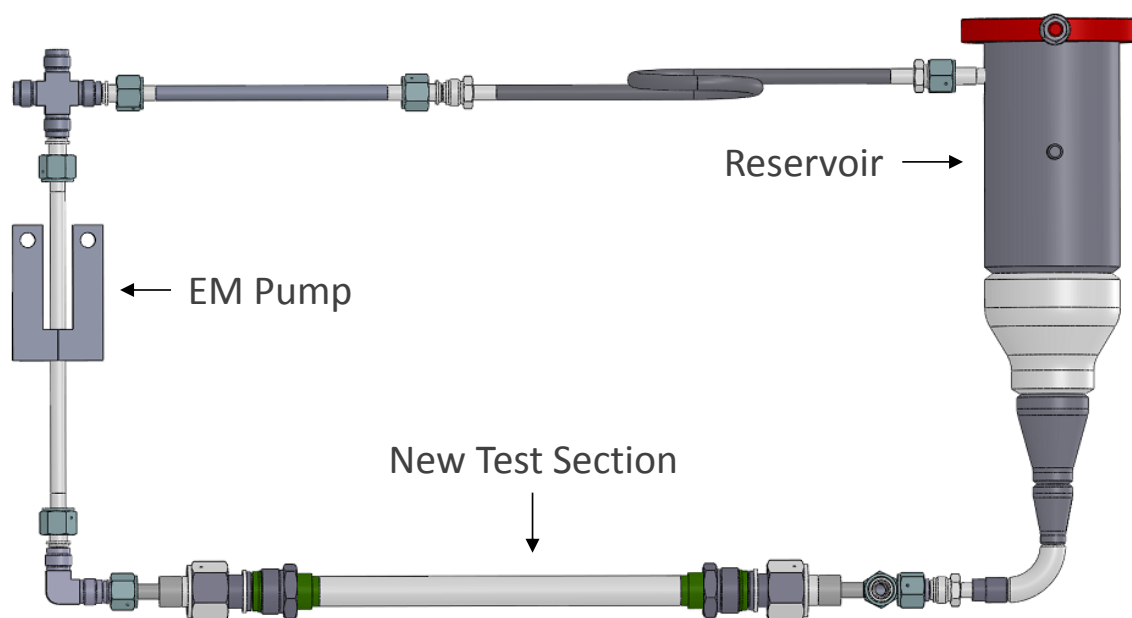
Figure 2. CAD drawing of the upgraded Sodium Freezing and Remelting test facility, not including the cold finger

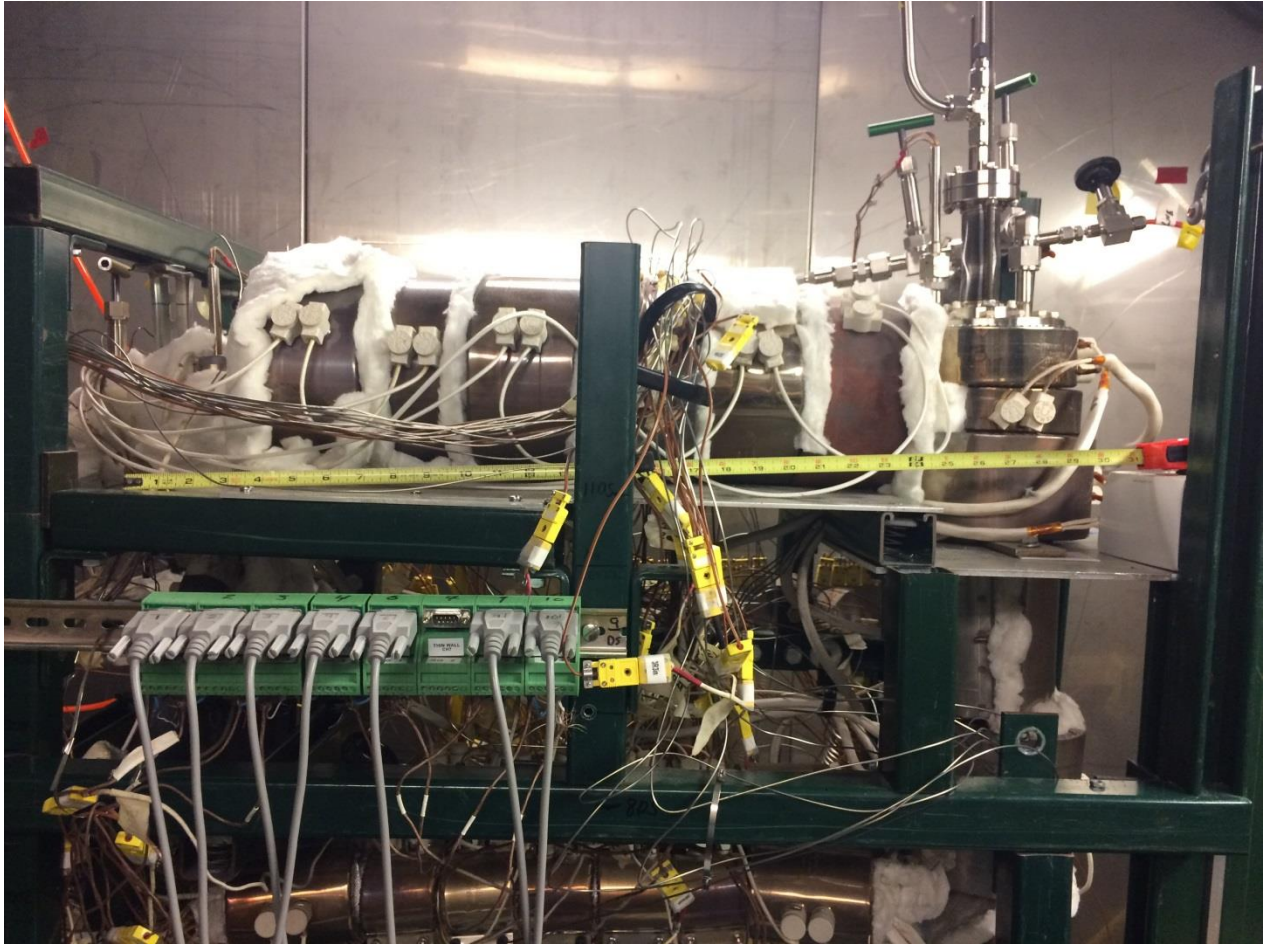
In addition to the upgrading of the freezing and remelting test section to a higher-temperature design, there have been other upgrades/modifications performed to the loop, mainly on the thermocouple instrumentation, EM pump, heating system, electrical connection, and data acquisition system. Shown in Figure 3 is the old Sodium Freezing and Remelting test facility that we started with in FY 2017. Compared to the modified/upgraded test facility shown in Figure 1, it is clearly seen that, the new test facility is much cleaner, neater, and better organized.

Figure 3. The Sodium Freezing and Remelting test facility before modifications/upgrades

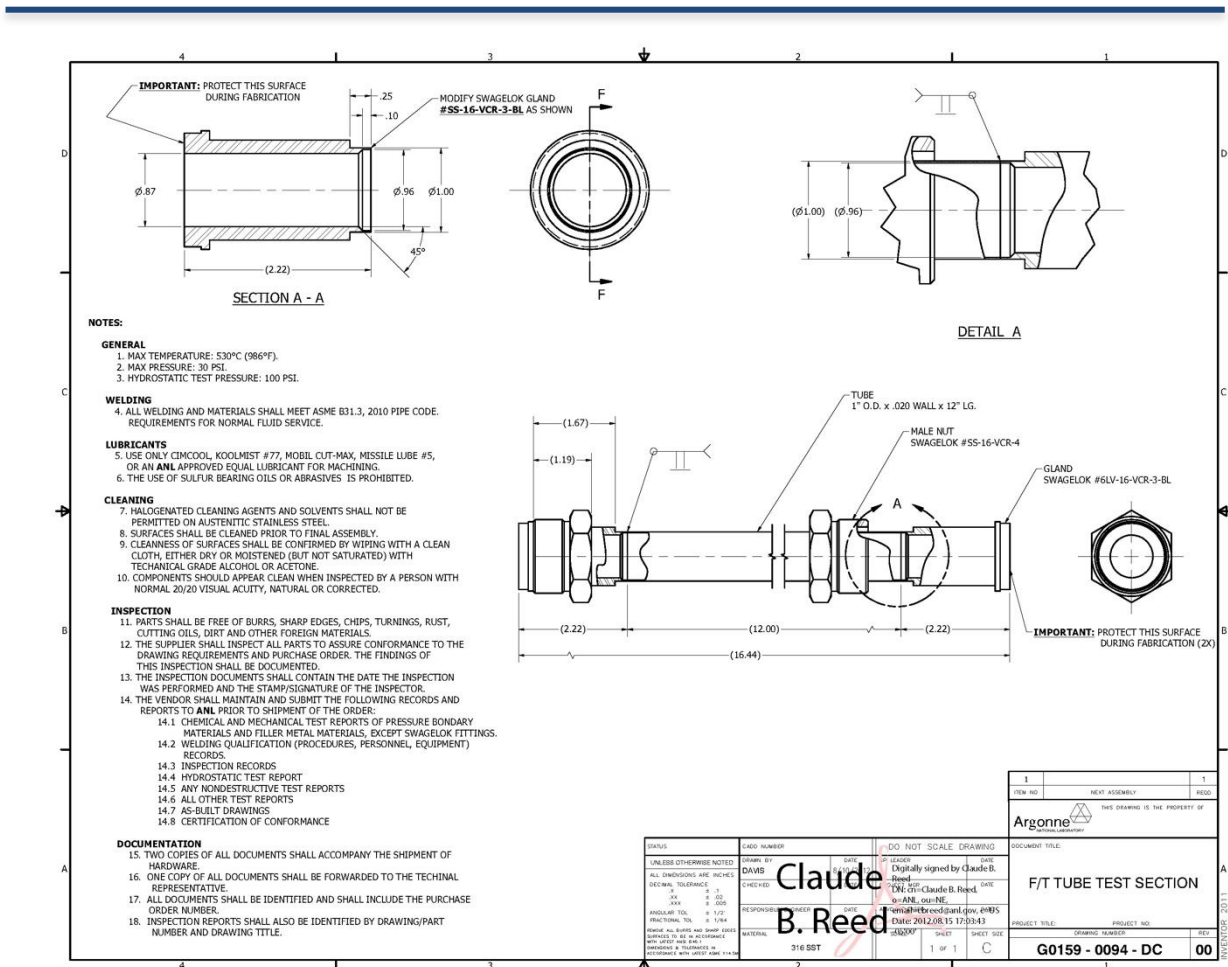
The new test section differs from the thick-walled 1 inch Schedule 40 pipe test section [5] in the old test facility. Higher-temperature strain gages are implemented on the new test section and the wall is much thinner to enhance the strains achieved. The high-temperature strain gages (model number of HBWAH-12-125-6-3MG-SHB) from Hitec Products, Inc [8] are applicable to temperatures up to 980°C. The test section is made from 1 inch OD \times 0.020 inch thick wall tube of material stainless steel (SS) 316. The overall length of the test section is 16.44 inches, and the fabrication drawing with detailed dimensions is shown in Figure 4.

Figure 4. Fabrication drawing of the new test section

The test section has 1 inch VCR fittings welded to each end. Each test section is heavily instrumented on its exterior surfaces with 26 Type K thermocouples and 8 high temperature strain gages. The 26 thermocouples are distributed both axially and circumferentially on the test section's outer surface so that the progression of the freezing or melting front along the length of, and around the circumference of, the test section can be recorded. The 8 strain gages are mounted at three axial locations, -4.8 inch from the center (2), +4.8 inch from the center (2), and the center of test section, and at 0°, 90°, 180°, and 270° around the test section circumference. Four of the eight strain gages are oriented to measure purely axial strain, while the other four strain gages are oriented to measure purely hoop strain. The detailed layout of the 26 thermocouples and 8 strain gages are summarized in Table 1 and Table 2.

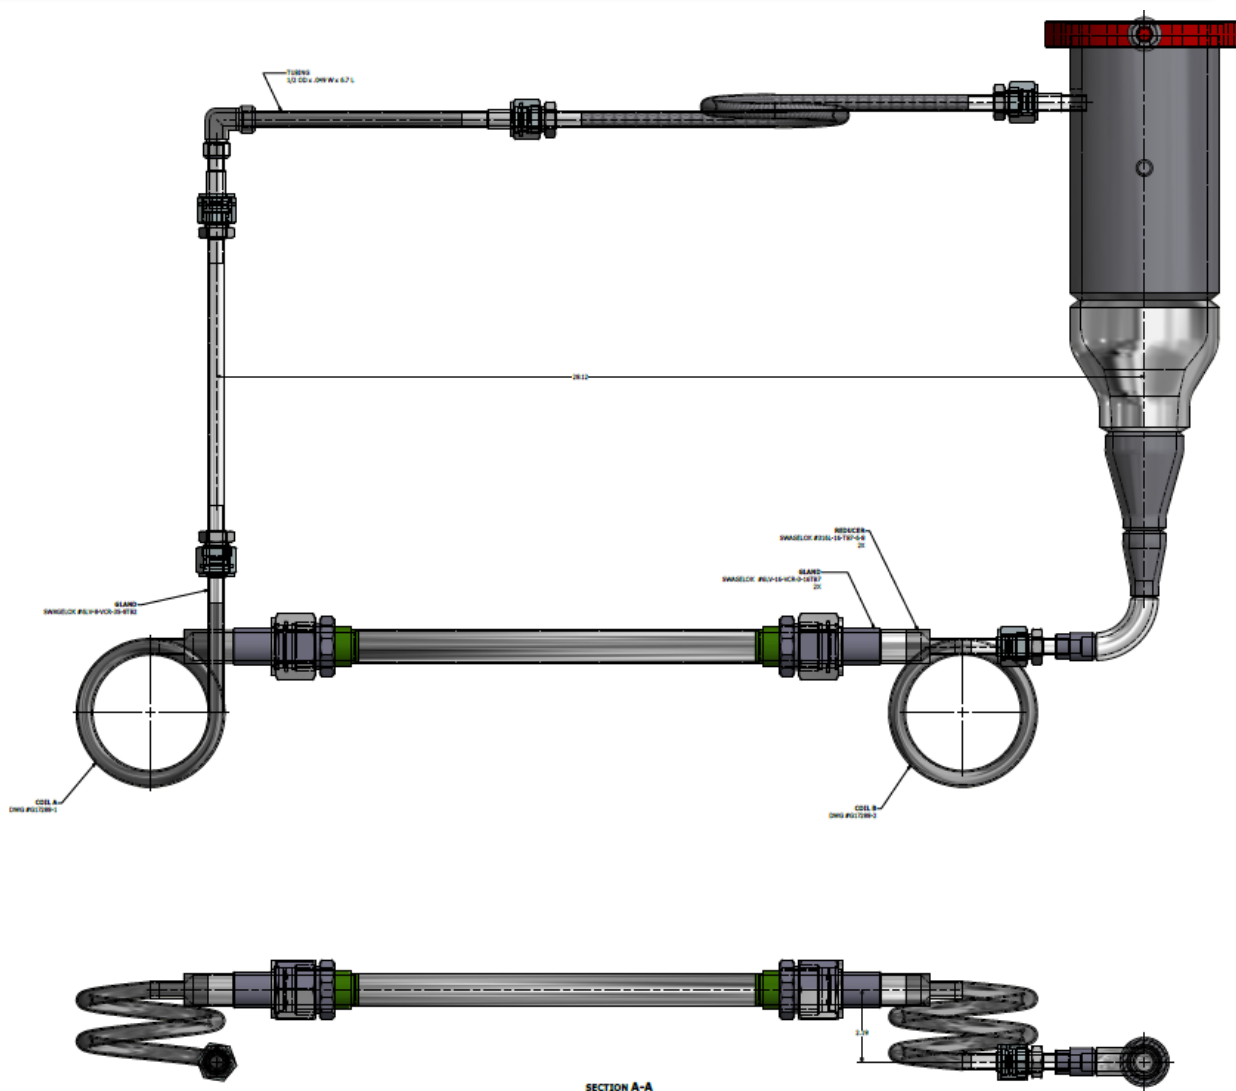
The test section has 1 inch VCR fittings welded on both ends, while the rest of the loop employs ½ inch VCR fittings. To connect the test section to the loop, two reducing connection pieces will be needed. When the work started in FY 2017, although the new test section was already fabricated, it was not finalized on how to connect the test section to the loop. At that time, an initial design using tube coils, as shown in Figure 5, was proposed. It was thought that the tube coils would provide the flexibility to eliminate any external stress from the loop onto the test section. However, calculations were not performed to confirm that thought. In addition, the use of the tube coils would complicate the operation and maintenance (e.g., tilting and draining the loop), as well as inducing increased pressure loss. In view of these considerations, it was decided to perform a study on the flexibility of these tube coils.

Figure 5. Initial design of connecting the test section to the loop using tube coils

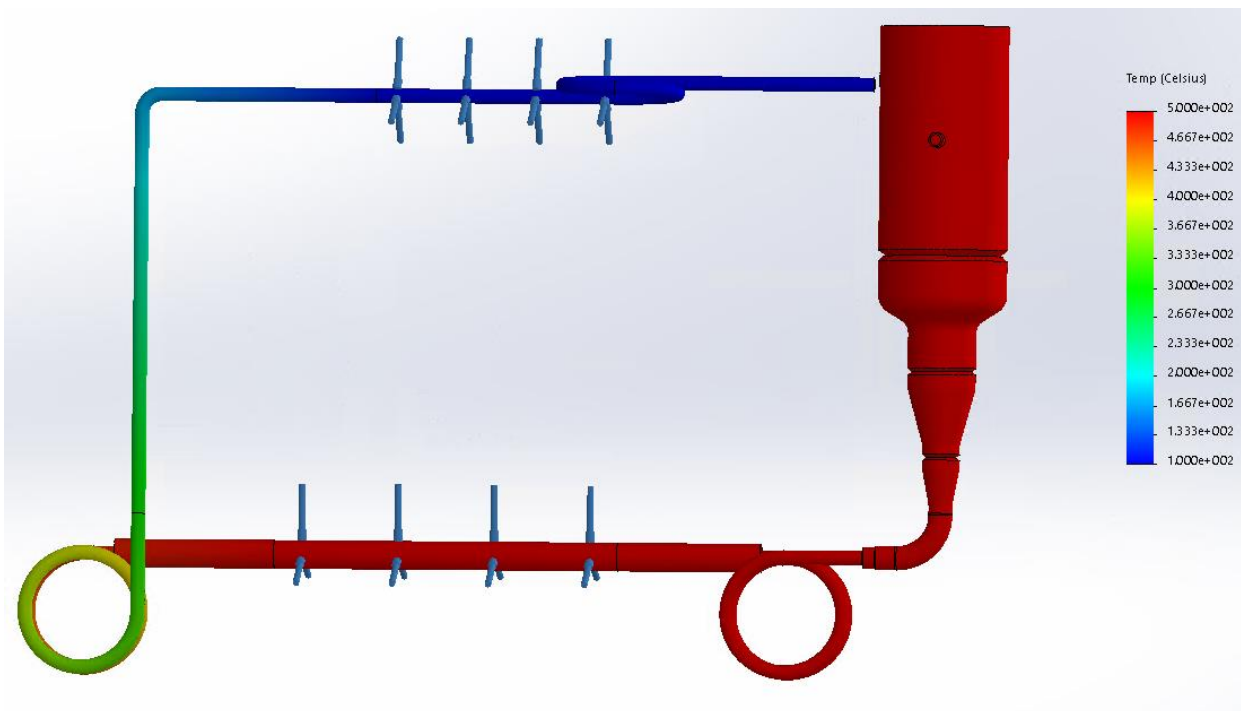
In this case, the top center piece is set at 100°C, and the test section is set at 500°C. The resulted temperature distribution is shown in Figure 6.

Figure 6. Temperature distribution for thermal study Case 1

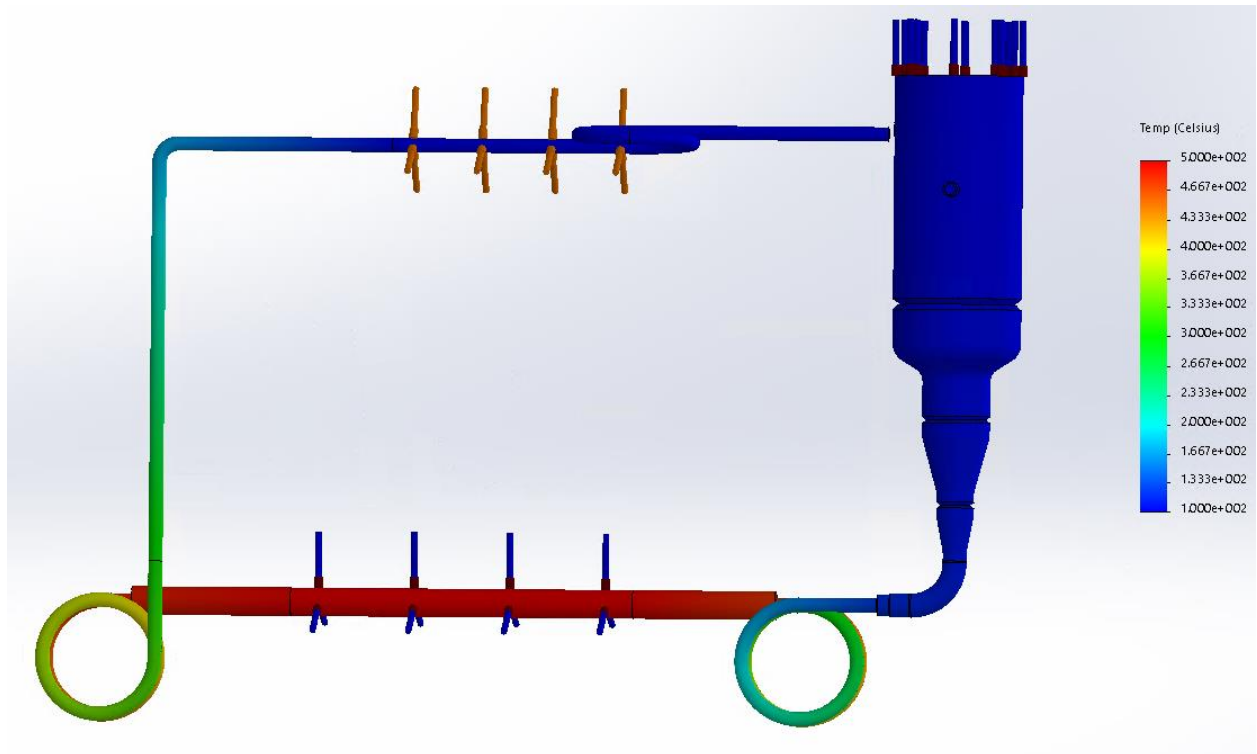
In this case, in addition to the boundary temperatures applied in Case 1, the top surface of the reservoir is also set at 100°C. The resulting temperature distribution is shown in Figure 7.

Figure 7. Temperature distribution for thermal study Case 2

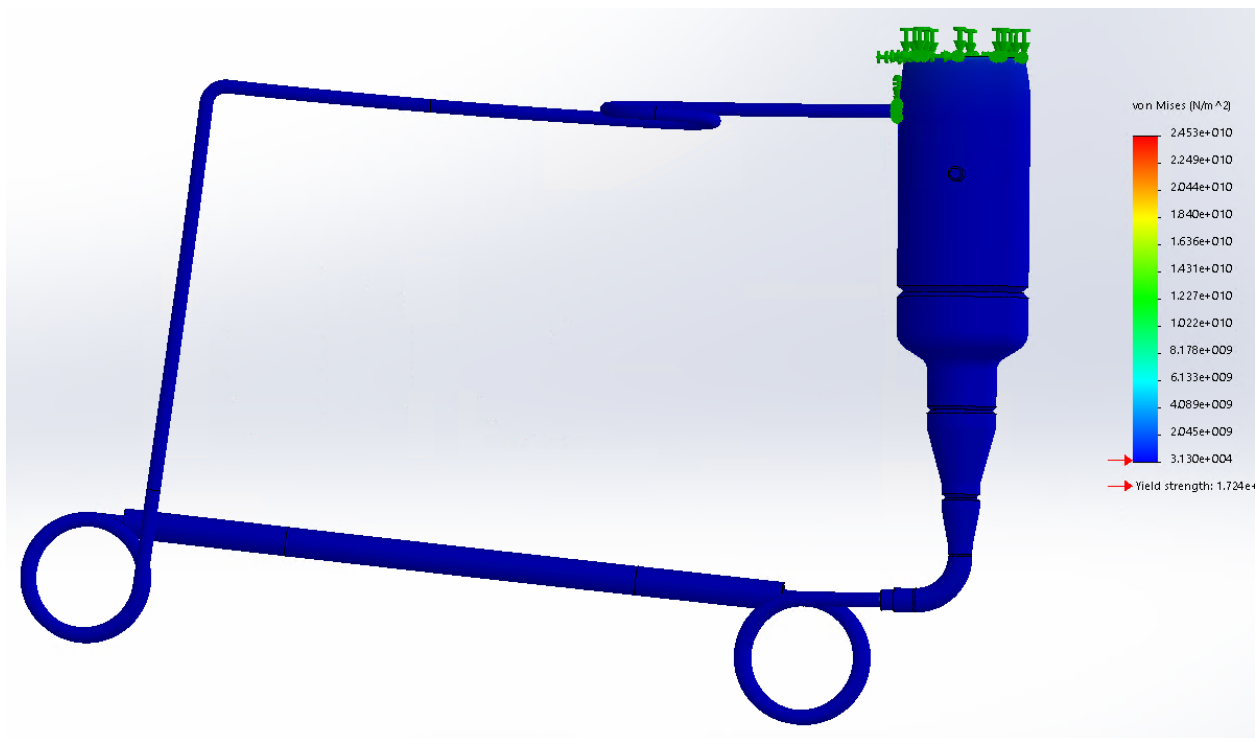
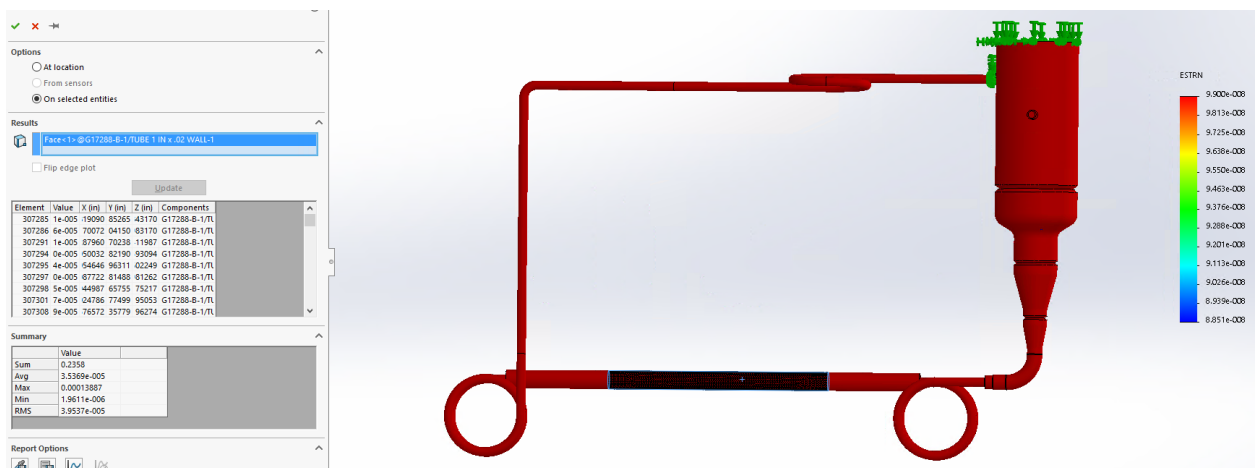
This case adopts the temperature distribution results from thermal study Case 1. In addition, the right end of the top leg and the top surface of the reservoir are fixed, as shown in Figure 8, along with the stress results. The strain results are shown in Figure 9, with a summary of the equivalent strain in the test section shown on the left. As can be seen, the average equivalent strain in the test section is approximately $3.54\text{E-}5$. Assuming the test section is heated up from 25 to 500°C and expands freely, the resulting axial thermal strain is approximately $7.60\text{E-}3$ (assuming a thermal expansion coefficient of $1.5\text{E-}5$ /K). Therefore, the additional strain accounts only for 0.47% of the thermal strain, and according to the aforementioned criterion, the desired flexibility is ensured. However, based on the deformation of the loop (Figure 8), a significant portion of the flexibility seems due to the loop itself. This issue will be discussed later.

Figure 8. Stress results for Case 1

Figure 9. Strain results for Case 1

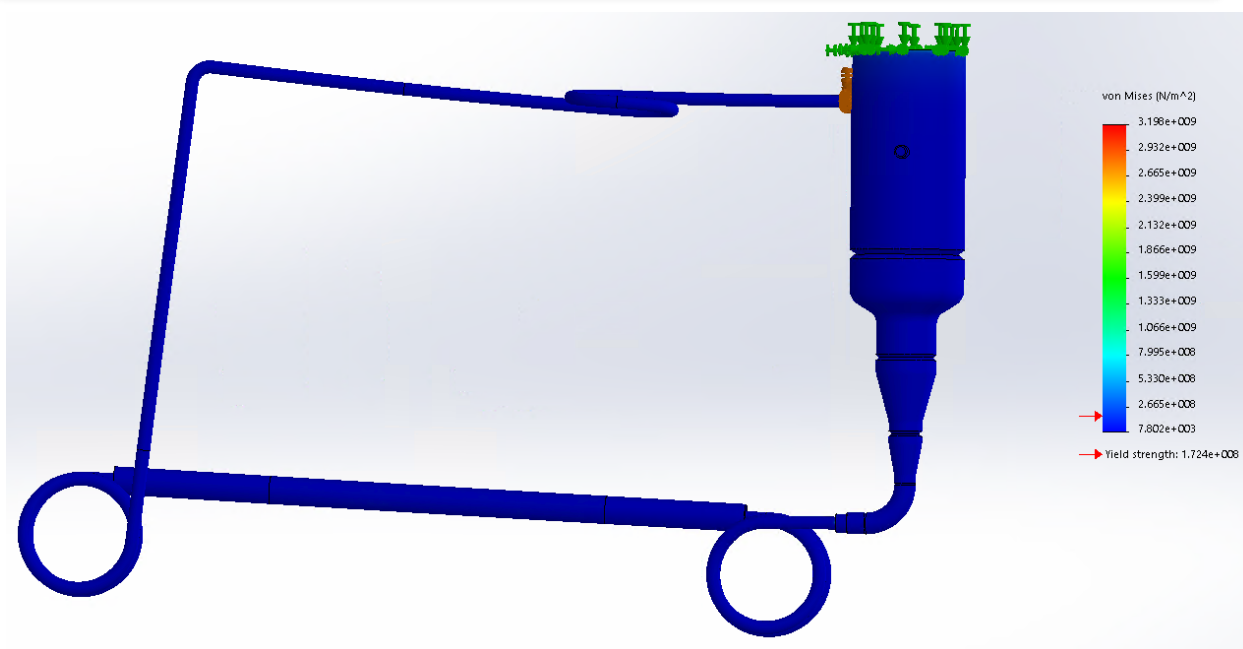
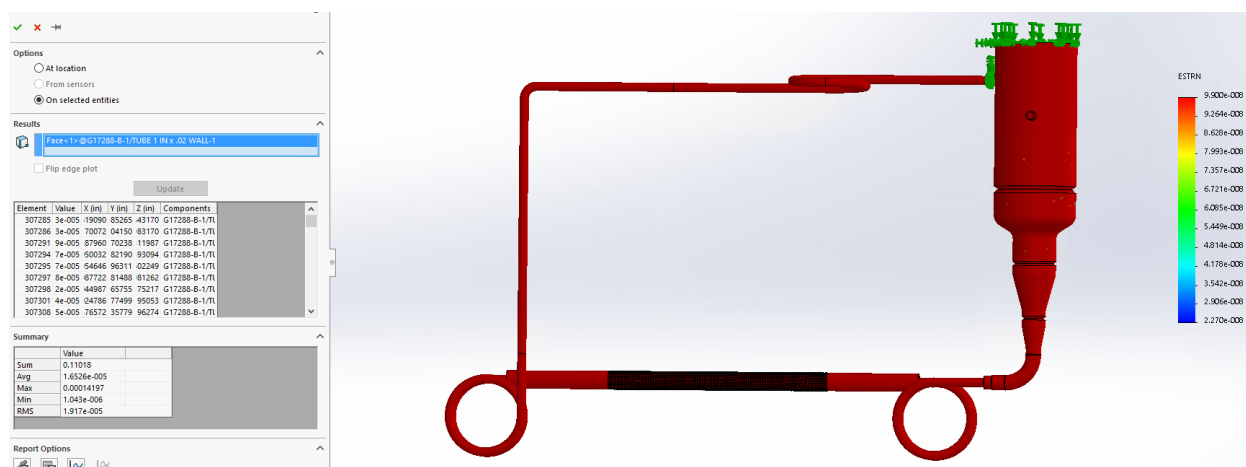
In this case, the same fixture boundary conditions as in the previous case are applied. However, the temperature distribution yielded by thermal study Case 2 is adopted. The stress and strain results are shown in Figure 10 and Figure 11. Again, the additional axial strain induced is negligible compared to the thermal strain.

Figure 10. Stress results for Case 2

Figure 11. Strain results for Case 2

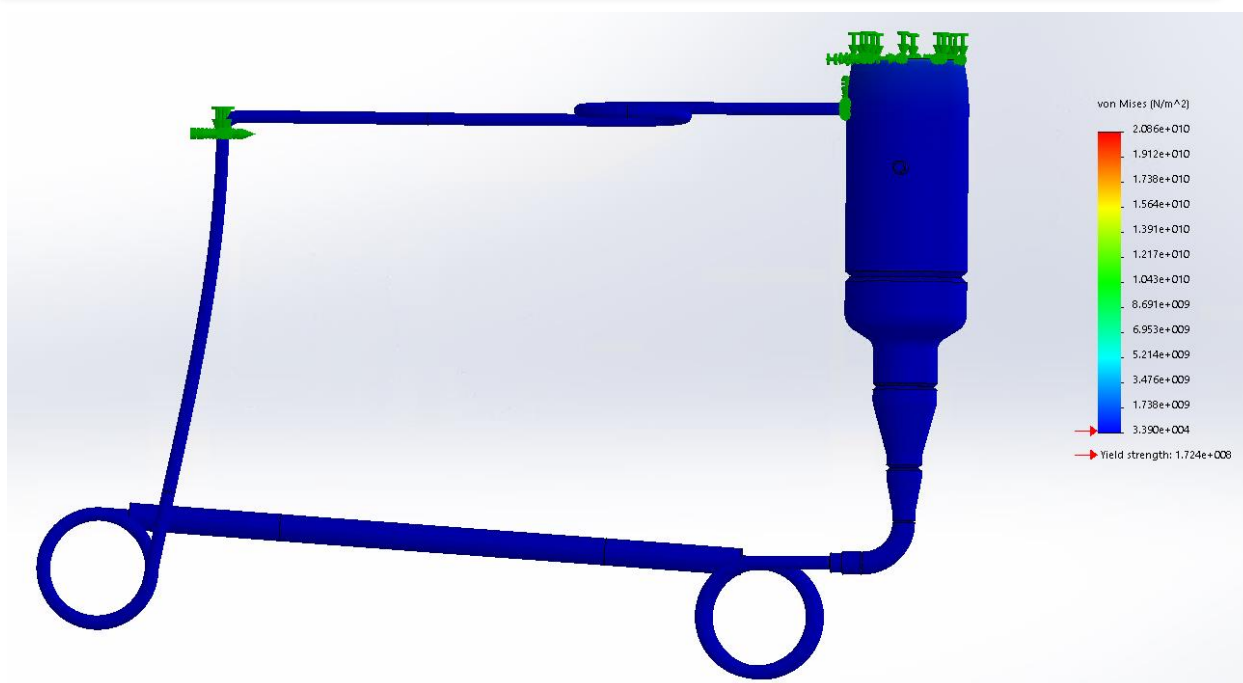
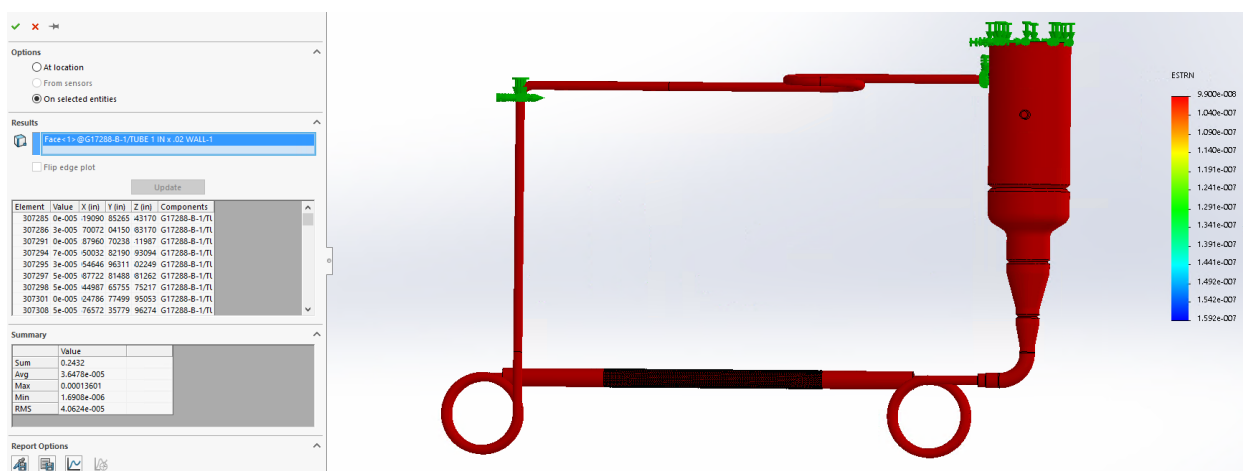
When running the experiments, to maintain good alignment between the magnets and electrodes of the EM pump, it is beneficial to add an anchor point near the EM pump. Therefore, in this case, one additional fixture is added to simulate the anchor. The results are shown in Figure 12 and Figure 13. As can be seen, the additional fixture causes a slight increase in the strain in the test section (compared to case 1), but still negligible compared to the thermal strain.

Figure 12. Stress results for Case 3

Figure 13. Strain results for Case 3

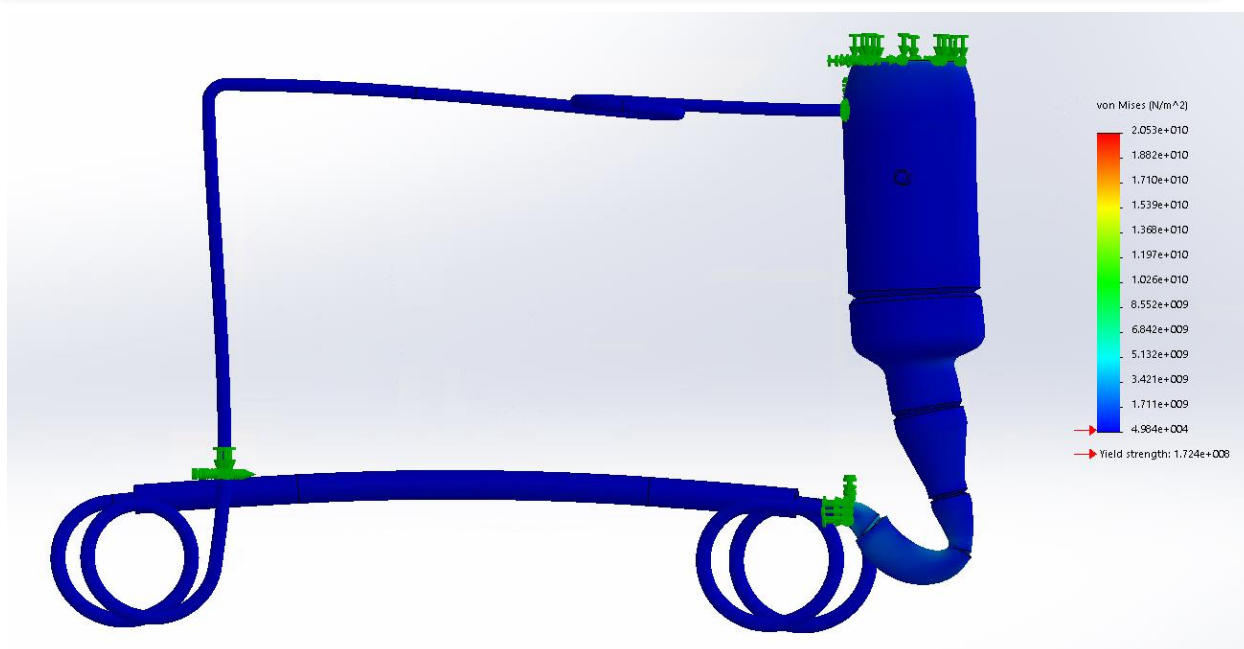
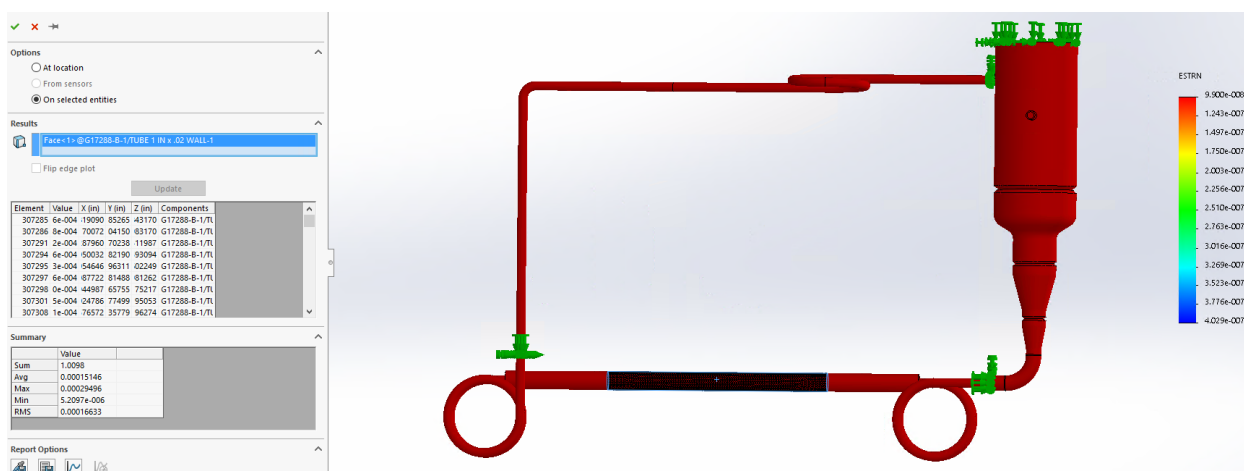
In the last case, the interfaces of the two coils with the loop other than the test section are fixed. The results are shown in Figure 14 and Figure 15. As can be seen, with the two ends of the two coils fixed, significant increases in the stress and strain are caused, indicating that the flexibility observed in the previous cases is greatly due to the loop itself. However, the additional axial strain in the test section now still only accounts for approximately 2% of the thermal strain. This means the coil is flexible enough to avoid causing additional strain in the test section, without assistance from the loop. However, its flexibility compared to that of the loop itself, does not seem to be a significant improvement. In view of this, it was decided to use the simple and straight connection pieces shown in Figure 2, which make the operation and maintenance of the test facility easier.

Figure 14. Stress results for Case 4

Figure 15. Strain results for Case 4

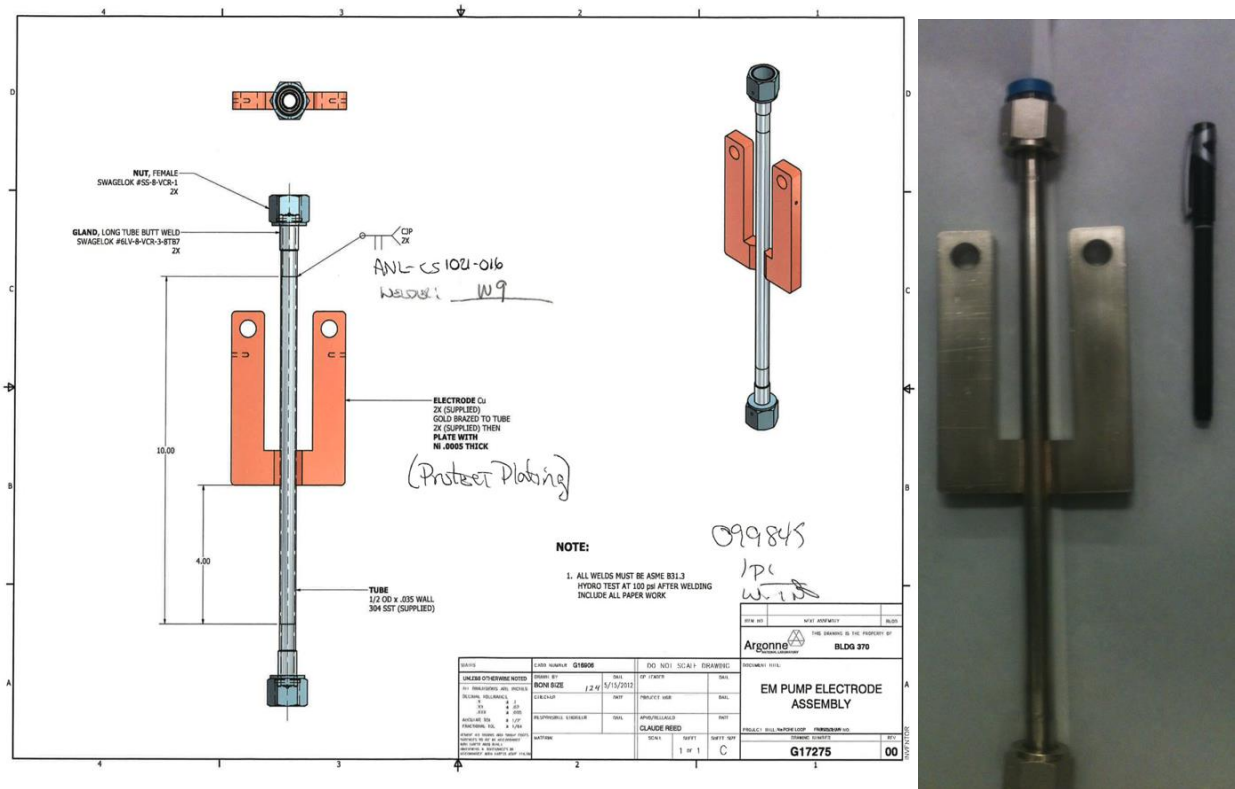
The EM pump, as shown in Figure 16, is a simple, permanent magnet, DC current-driven, conduction electromagnetic device. The duct is $\frac{1}{2}$ inch \times 0.035 inch wall tubing about 13 inches long, with oxygen-free copper electrodes brazed to the outsides of the tube, and then nickel plated to minimize high temperature oxidation of the copper electrodes. Samarium-cobalt permanent magnets are used for their high magnetic field strength, exceptional temperature resistance, and reliable performance without oxidation. The EM pump power supply is an Electronic Measurements, INC. Model 10-1000-2-LB high frequency switching ESS Power Supply providing up to 1000 A at the very low voltage drop across the EM pump electrodes, duct, and sodium inside.

Figure 16. Drawing of EM pump duct and copper electrodes (left), and EM pump duct and electrode assembly after nickel plating

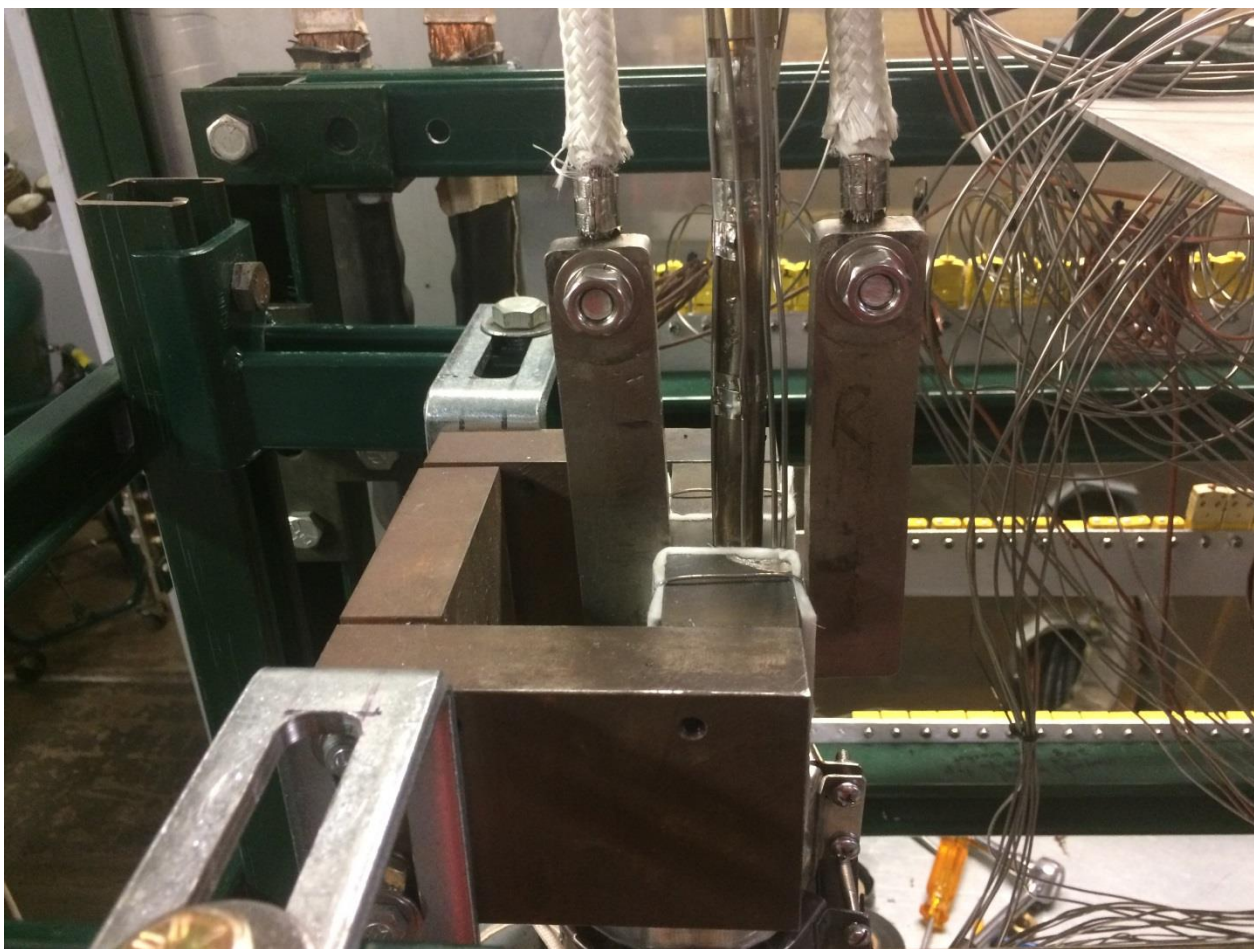
Two improvements were made to the EM pump. First, in the old test facility, the EM pump was installed in a way that the electrode plane was perpendicular to the loop plain. The issue with this EM pump orientation is that when the loop is heated and thermally expands, the EM pump duct and electrodes will contact the magnets that are fixed, causing external stress on the loop as well as a potential electrical short. Therefore, when the test facility was reassembled, we decided to rotate the EM pump by 90°, so that the pump duct along with the electrodes can move freely in the gap between the two magnets when the loop thermally expands, as shown in Figure 17. In addition, as may be noticed, the EM pump duct is not positioned exactly at the centerline of the magnet set, but slightly toward the right as shown in Figure 17. This intentional misalignment was to account for the thermal expansion of the loop when heated. Second, in the old test facility, a thin layer of mica sheet was attached to the magnet surfaces to provide the necessary electrical insulation between the electrodes and magnets. This was not deemed as a reliable design. The mica sheets were replaced with thicker ceramic fiber sheets that were fixed to the magnets with steel wires, as shown in Figure 17. The thicker ceramic fiber sheets provide not only the necessary electrical insulation but also good thermal insulation.

Figure 17. Picture showing the orientation of the EM pump

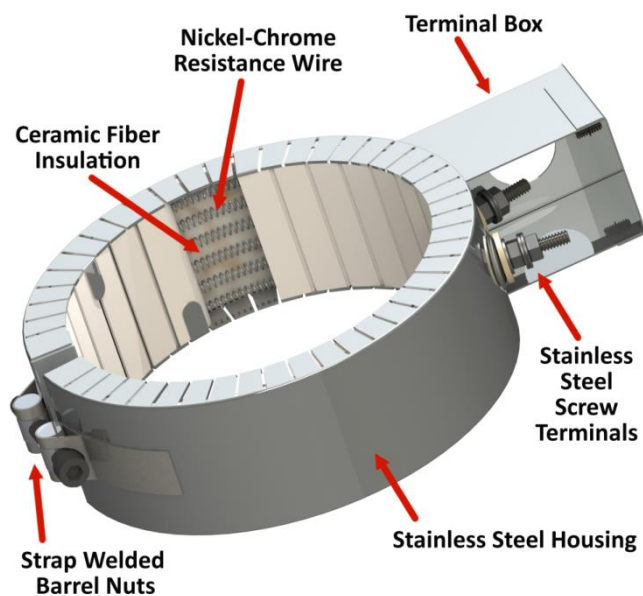
Twelve (12) separate, independent heating zones are implemented to properly and flexibly melt and freeze the apparatus and test section. Ceramic band heaters, as shown in Figure 18, are used for heating zones. One of the modifications to the test facility was on the heating of the EM pump. Previously, the pump duct above the magnets was heated with mica insulated contact heaters, and the electrodes were heated with ceramic strip heaters. In the new test loop, all those heaters were removed and replaced with large diameter ceramic band heaters encompassing both the pump duct and electrodes for heating. Heating or cooling is controlled for each zone by its own independent proportional-integral-difference (PID) controller. A separate, independent temperature limit controller is also provided for each zone. A photo of the Zones 1-6 front panel is shown in Figure 19.

Figure 18. Ceramic band heaters

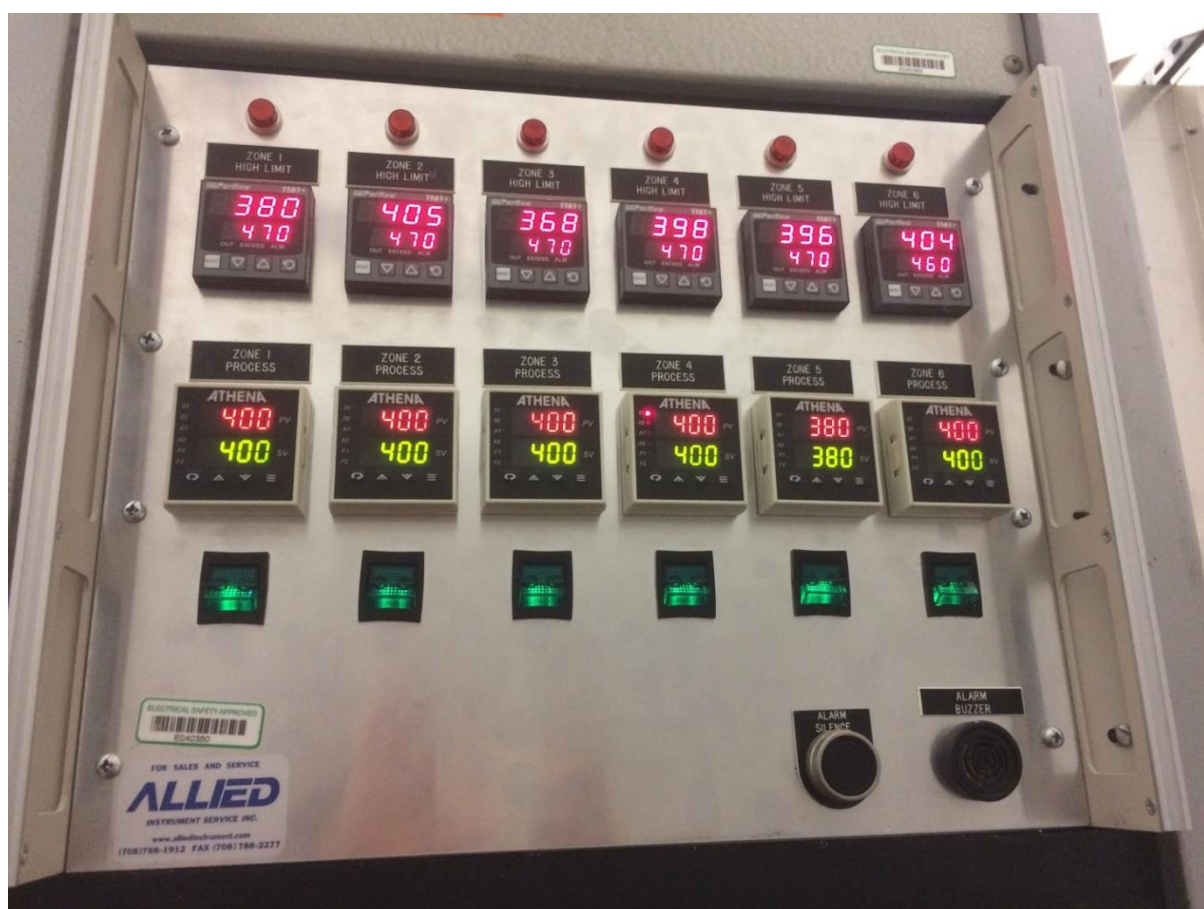
Figure 19. Front panel of heater control system for Zones 1-6 (picture taken during the ~ 400°C test performed in FY 2017)

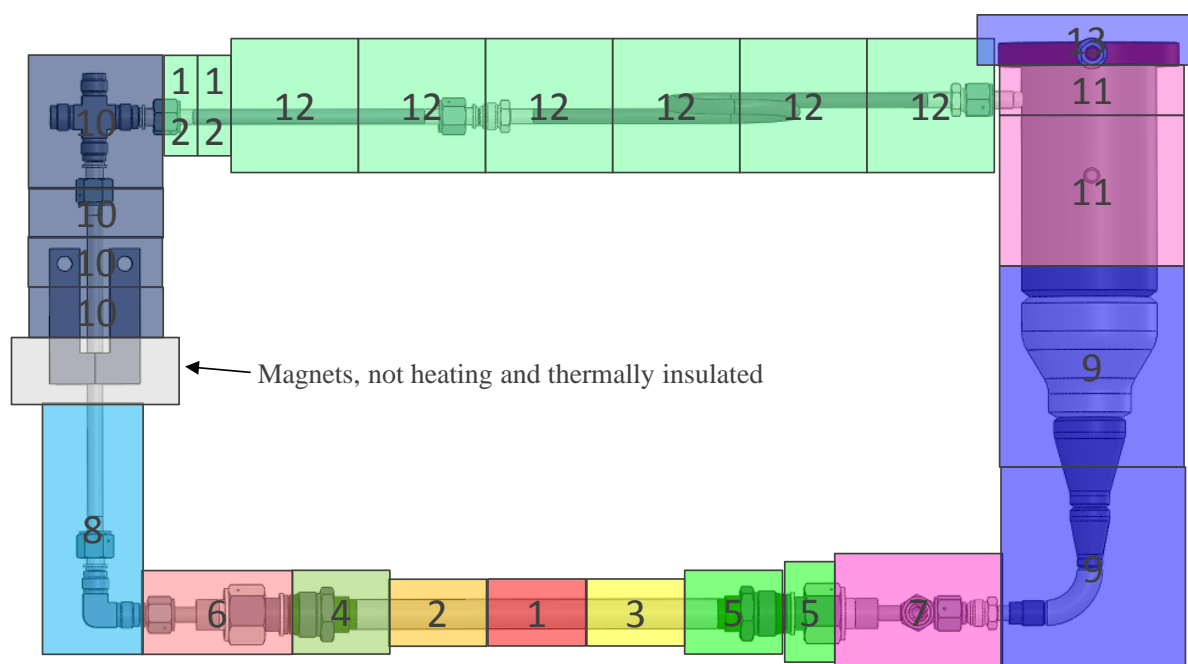
The heating zones had to be modified mainly due to the modification to the test section. Also, as mentioned above, heating of the EM pump region was modified, thus requiring the modification of the corresponding heating zone. A map of the new heat zones is shown in Figure 20.

Figure 20. Updated heating zones for the Freezing and Remelting test facility

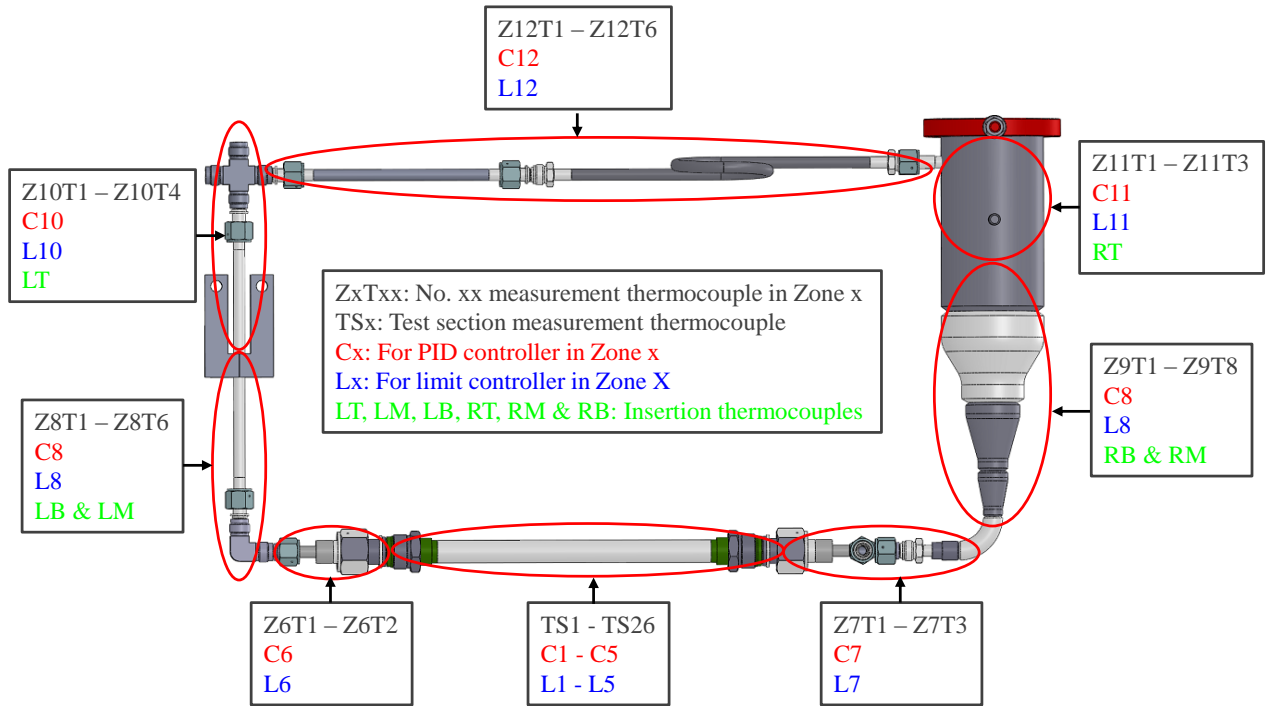
When disassembling the old test facility, to facilitate the process, most of the old thermocouples were removed. After the reassembly was completed, new thermocouple instrumentation was designed and implemented. A total of 112 Type K thermocouples were installed in the new Freezing and Remelting test facility. Among these 112 thermocouples, 26 are located at the test section, as discussed earlier. There are 40 thermocouples used to measure the loop temperatures, among which 32 thermocouples are welded to the surface of the loop, 6 are inserted into the loop, and 2 are used to monitor the magnet temperature. There are 24 thermocouples connected to the power control system, 12 for PID temperature controllers and the other 12 for temperature limit controllers. The remaining 22 thermocouples are inserted into the leak detecting holes of all the VCR fittings (2 holes per VCR connection) to monitor for sodium leakage. These thermocouples are connected to a PLC warning system, and whenever a leak is detected, the system will immediately notify the personnel in charge so that proper actions can be taken in time. The approximate layout of all the instrumented thermocouples can be found in Figure 21

Figure 21. Layout of the instrumented thermocouples
